Degradation of nuclear structures during operation

2.	Degradation of nuclear structures during operation
2.1.	Aging, Neutron Embrittlement, Structural Material Parameters
2.2.	Stress Corrosion Cracking
2.3.	Fatigue
2.4.	(Unexpected events)

Integrity of Nuclear Structures - Material Degradation and Mitigation by NDE

TPU Lecture Course 2014/15

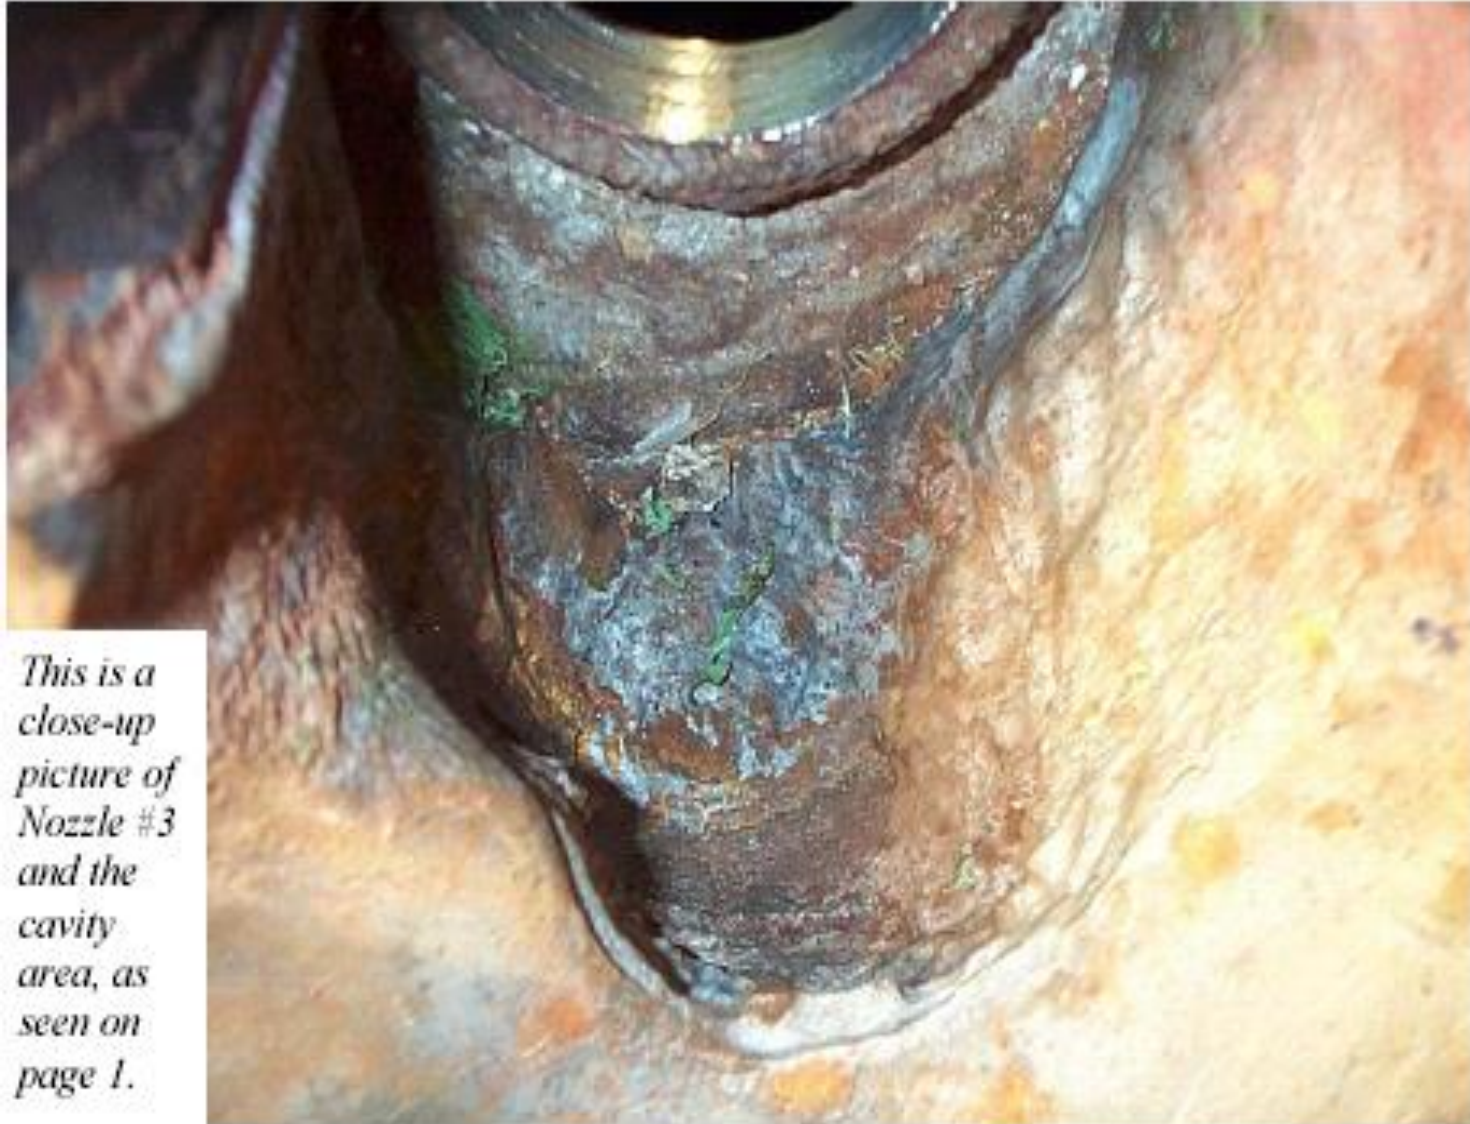
This is a close-up picture of Nozzle #3 and the cavity area, as seen on page 1.

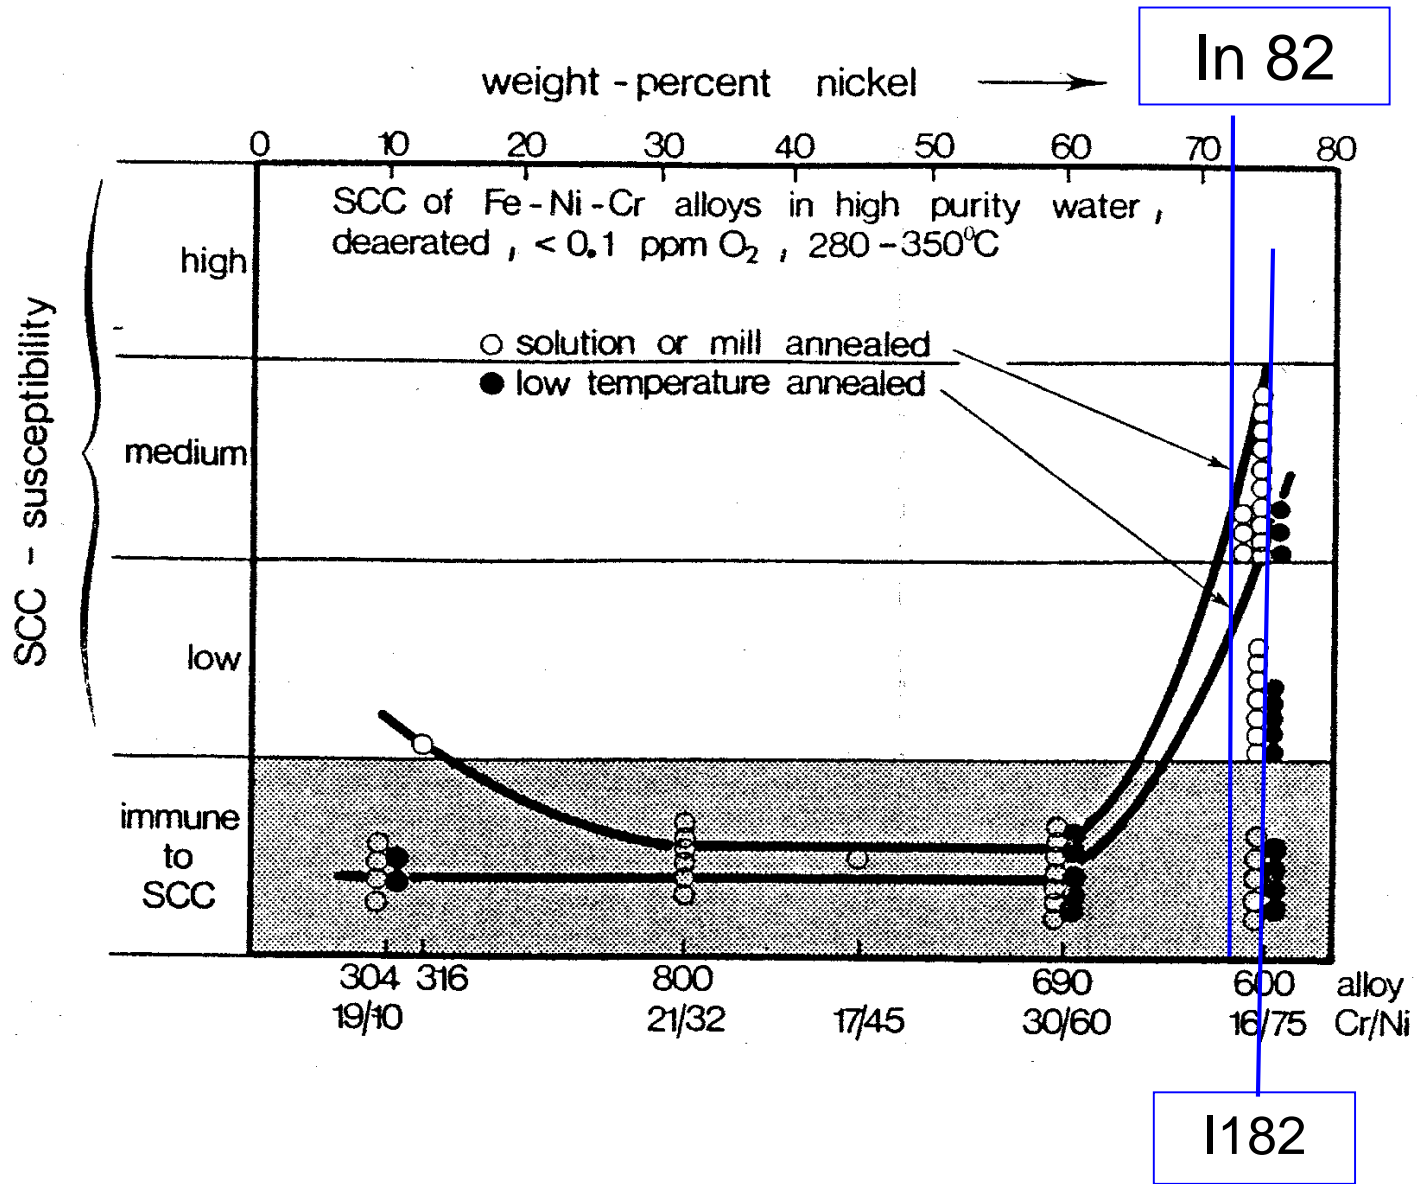
Effect of Nickel Content on IGSCC Susceptibility in High Temperature Water

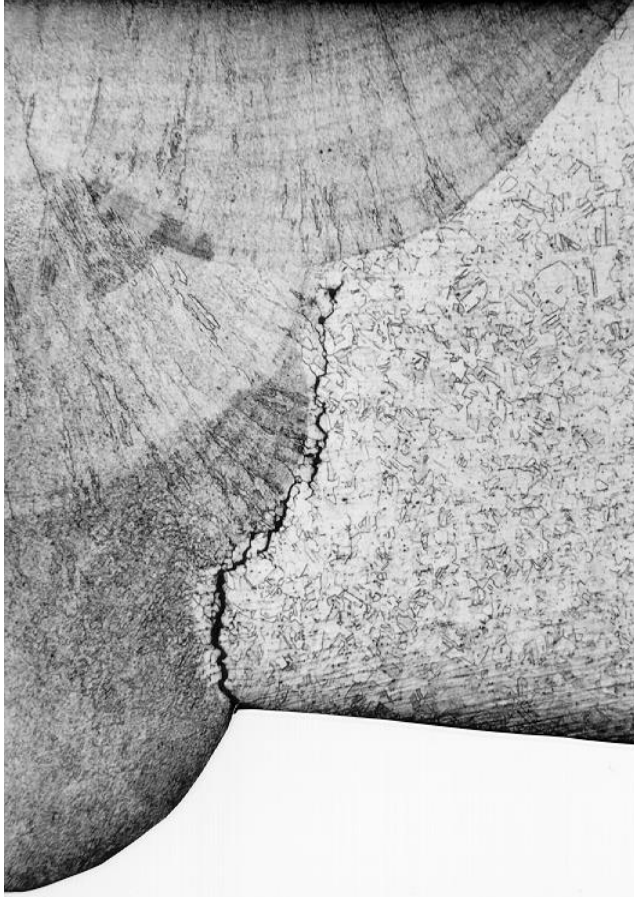
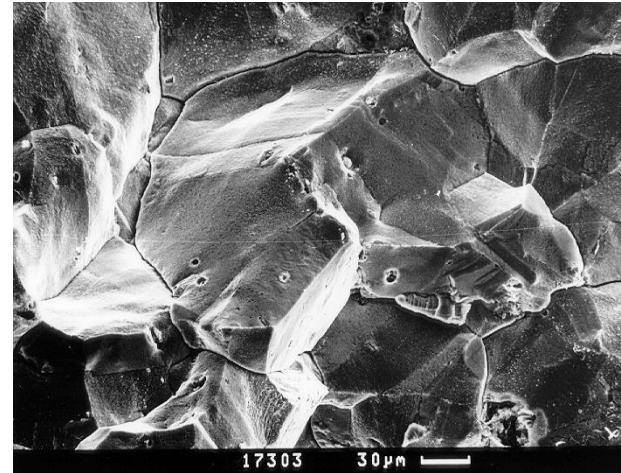
IGSCC due to Sensitization by Chromium Depletion

SEM

TEM

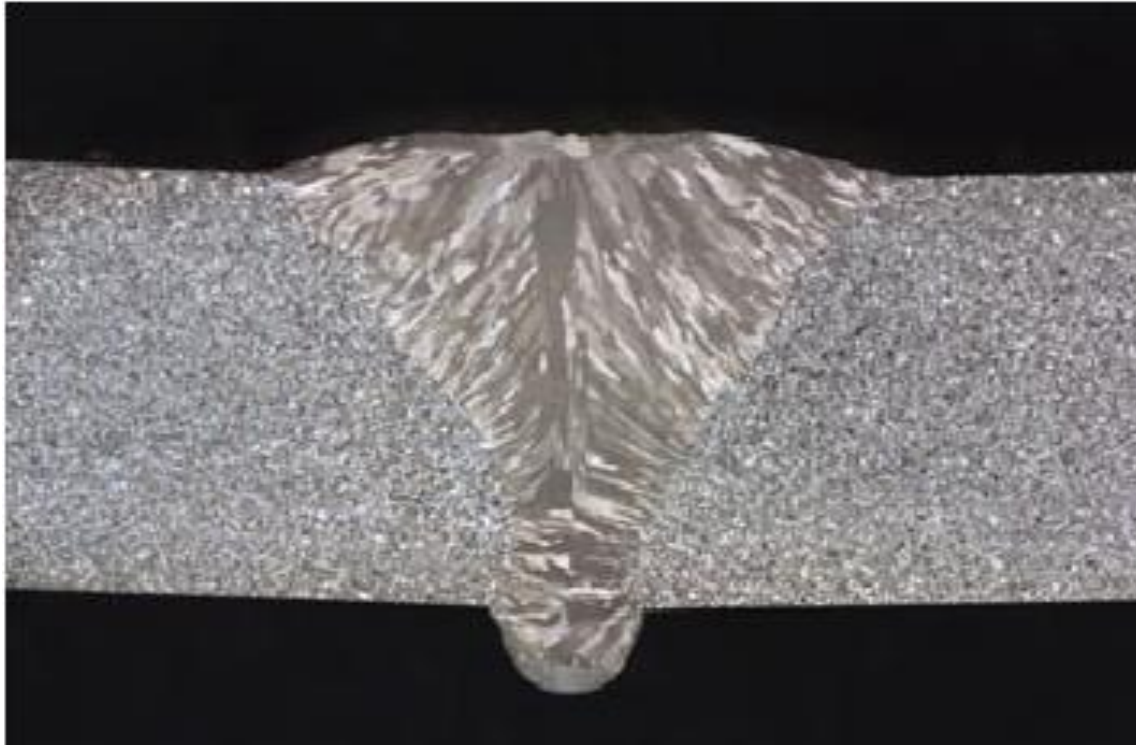
IGSCC in Austenitic Steel 304 Grade

Standard Weld Design

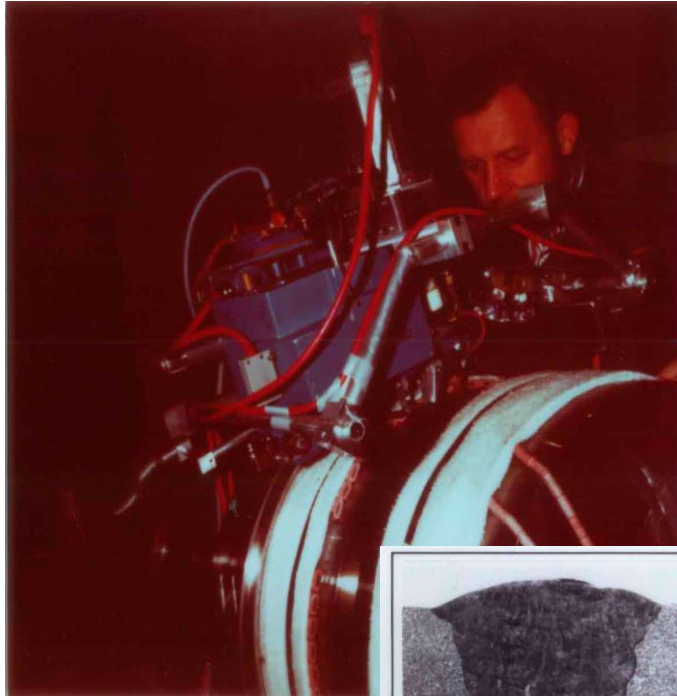
Pipe Welding with Orbital Welding Head (TIG)

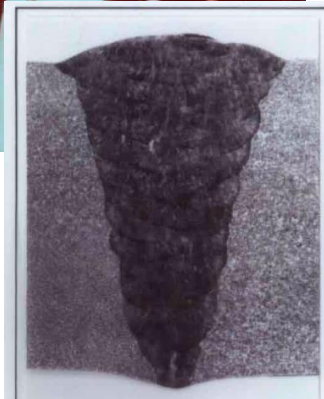
Konventionelle Schweißnaht
Conventional Weld

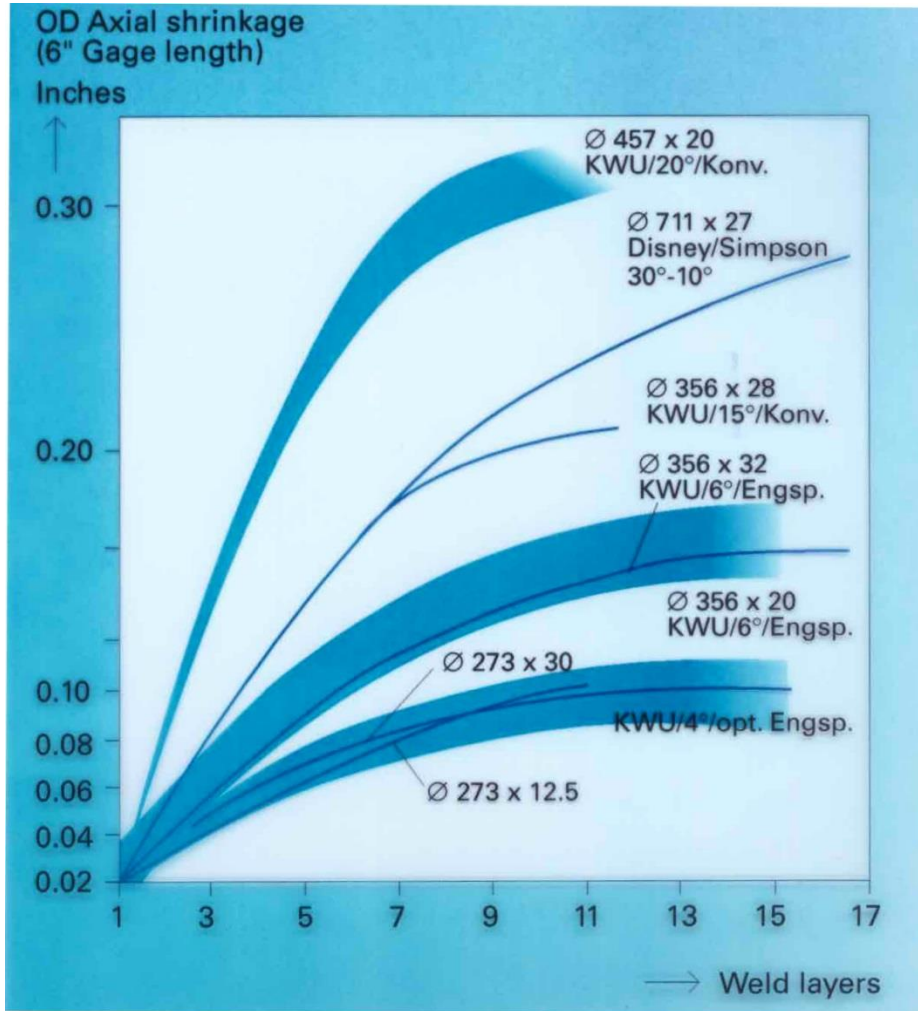
Shrinkage in TIG-Orbital Welding (Conventional Gap - Optimized Narrow Gap)

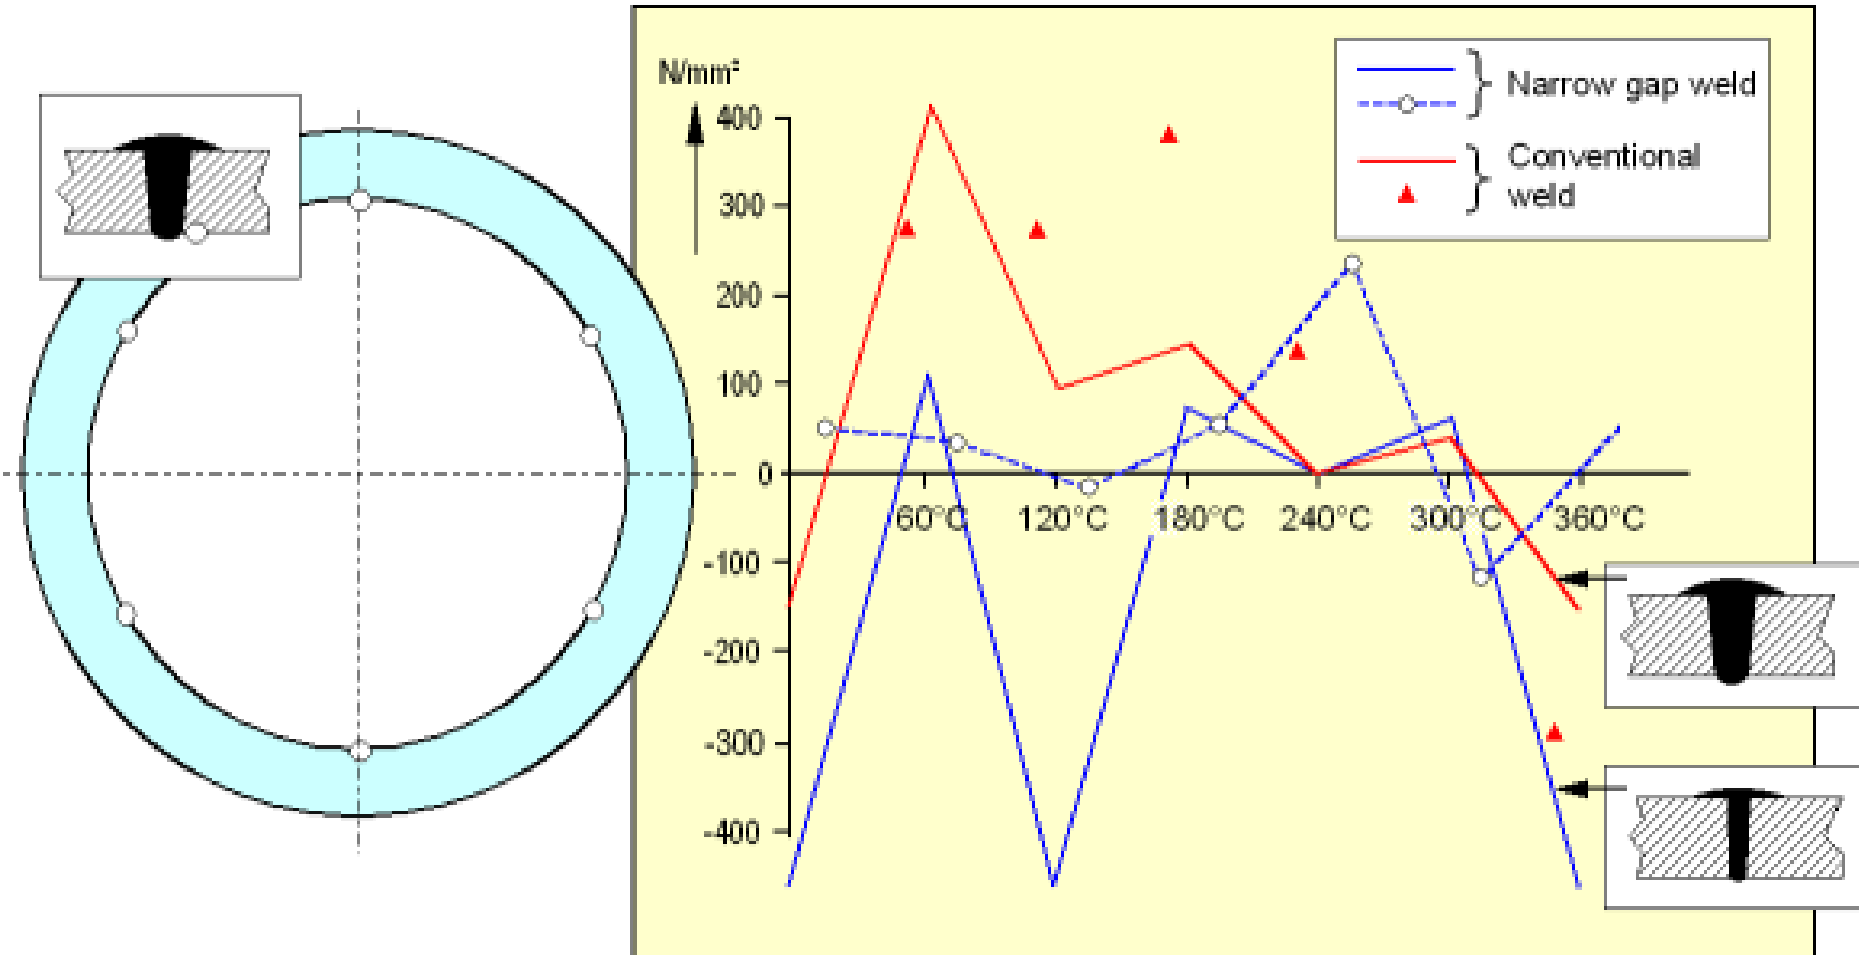
Residual Stress State

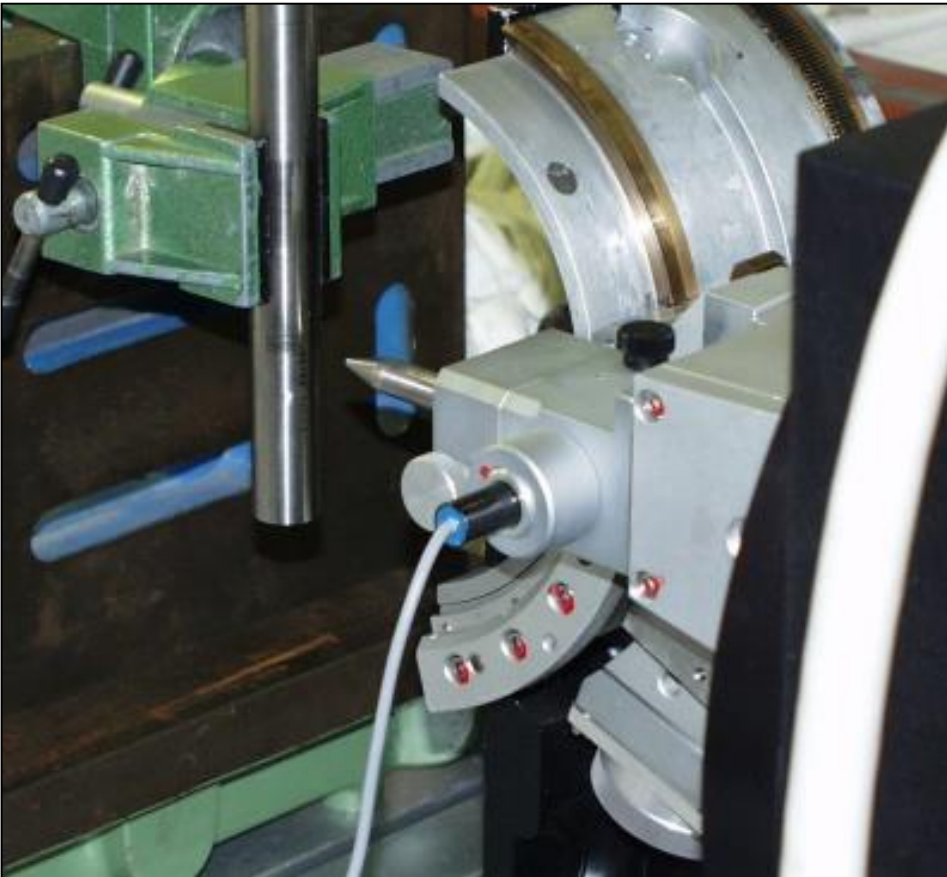
X-Ray Diffraction Method

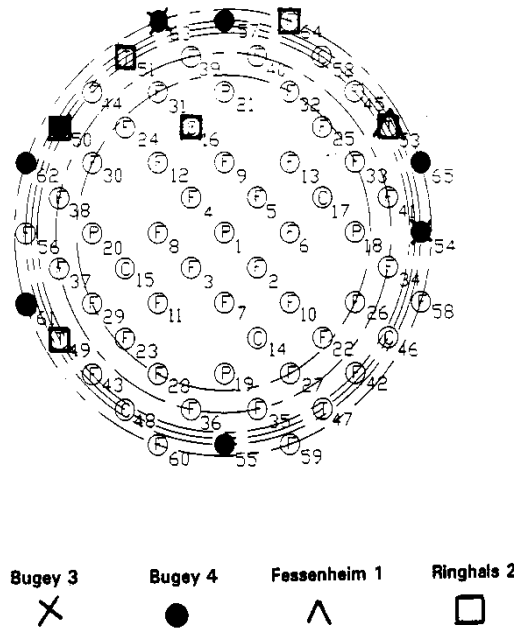
Axial Cracks

Position of cracks in RPV CRDM nozzles

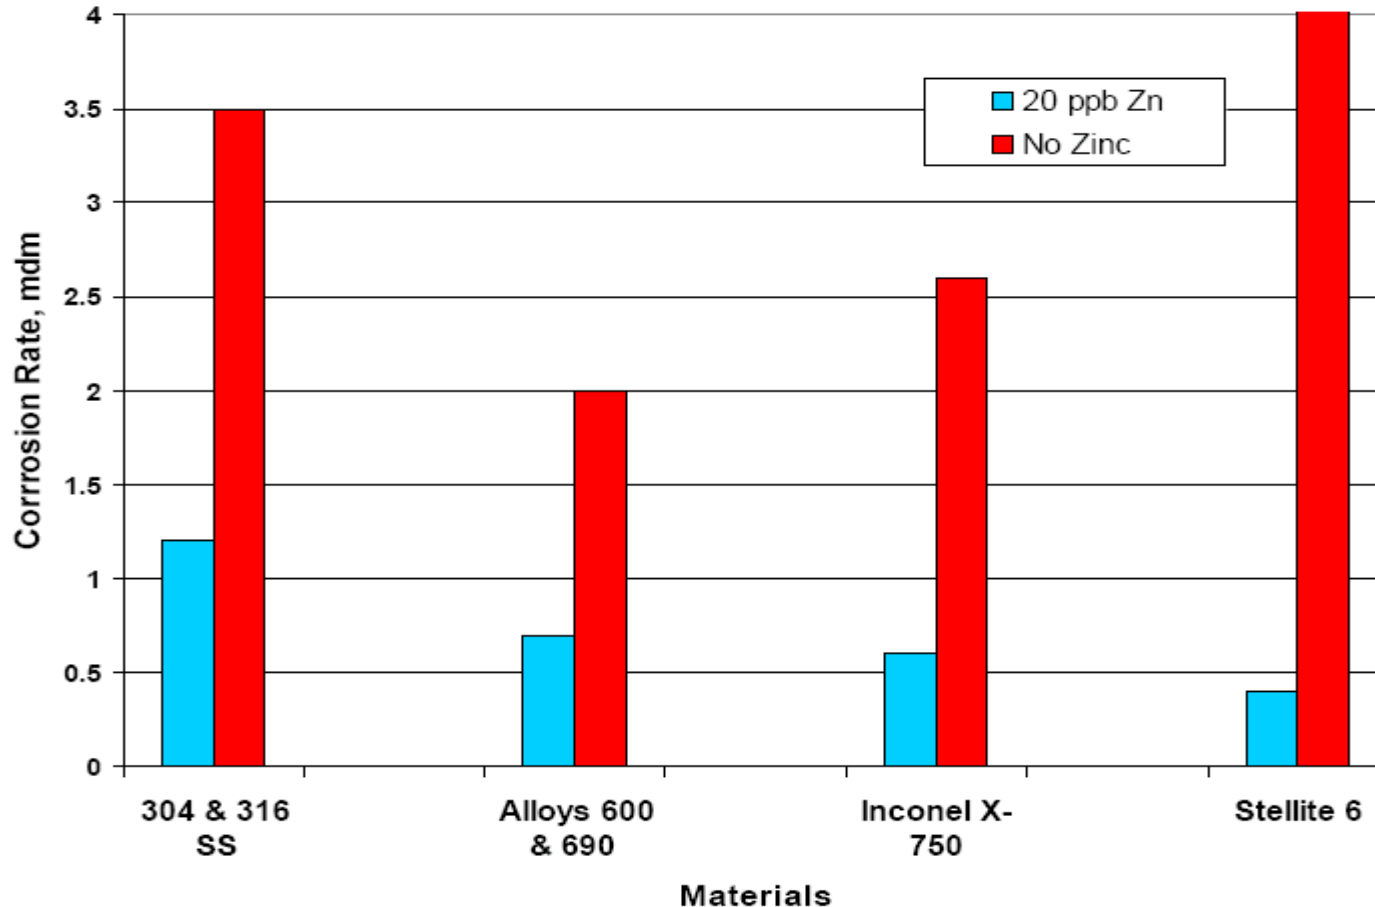
Corrosion Rate at 3.5 Months for Various Alloys

Effect of zinc on corrosion rates of various alloys in laboratory tests (after Esposito et al.)

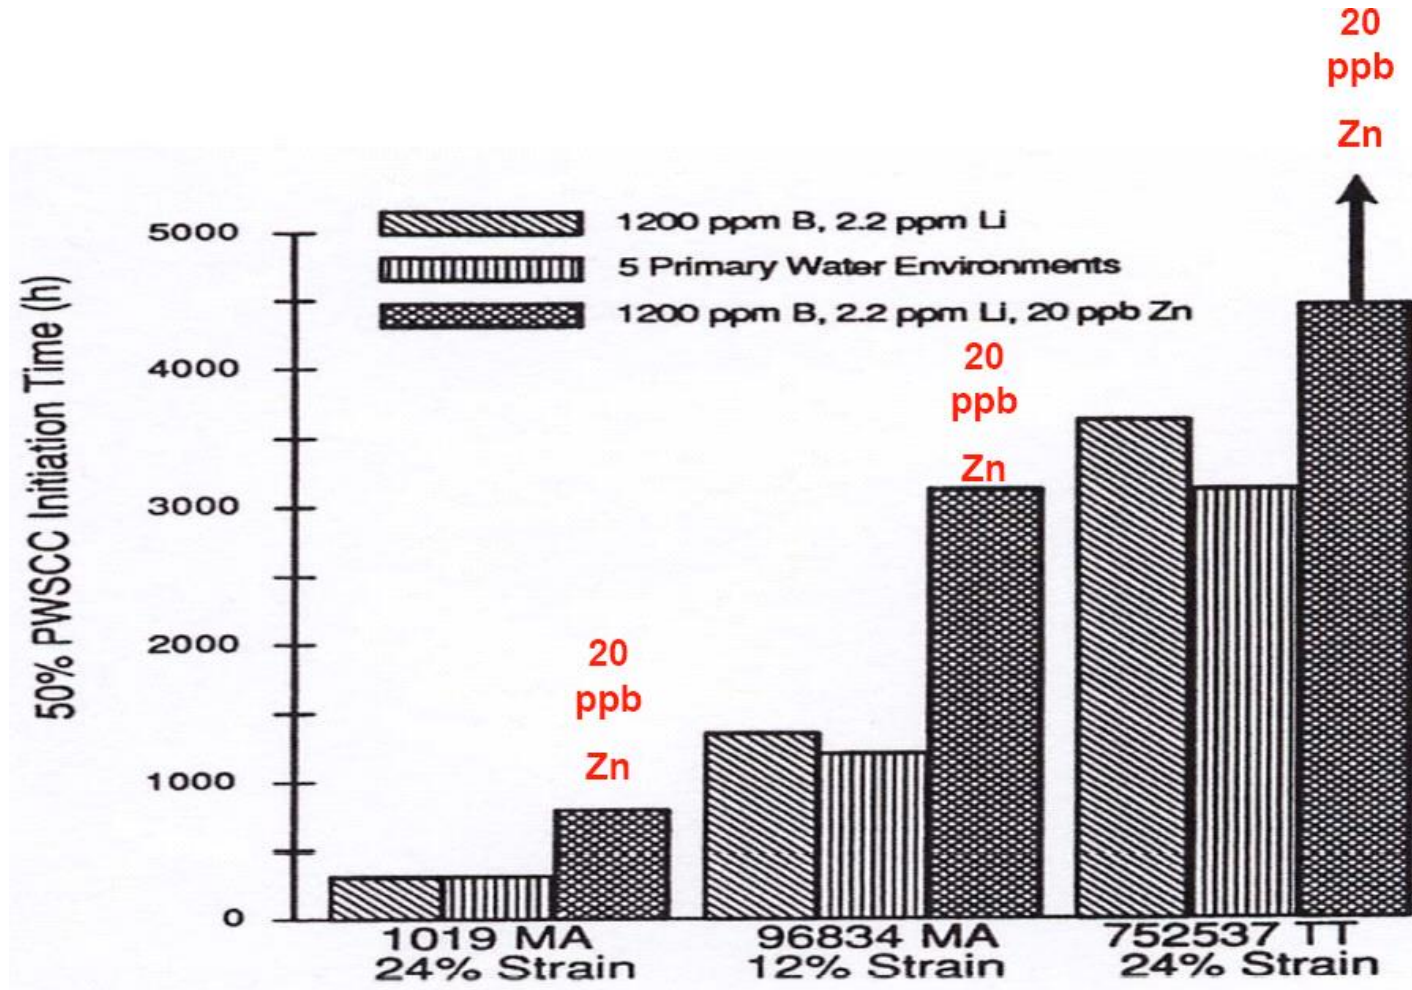
Example for the effect of zinc on time to initiate PWSCC in laboratory tests (Esposito et al. 1991)

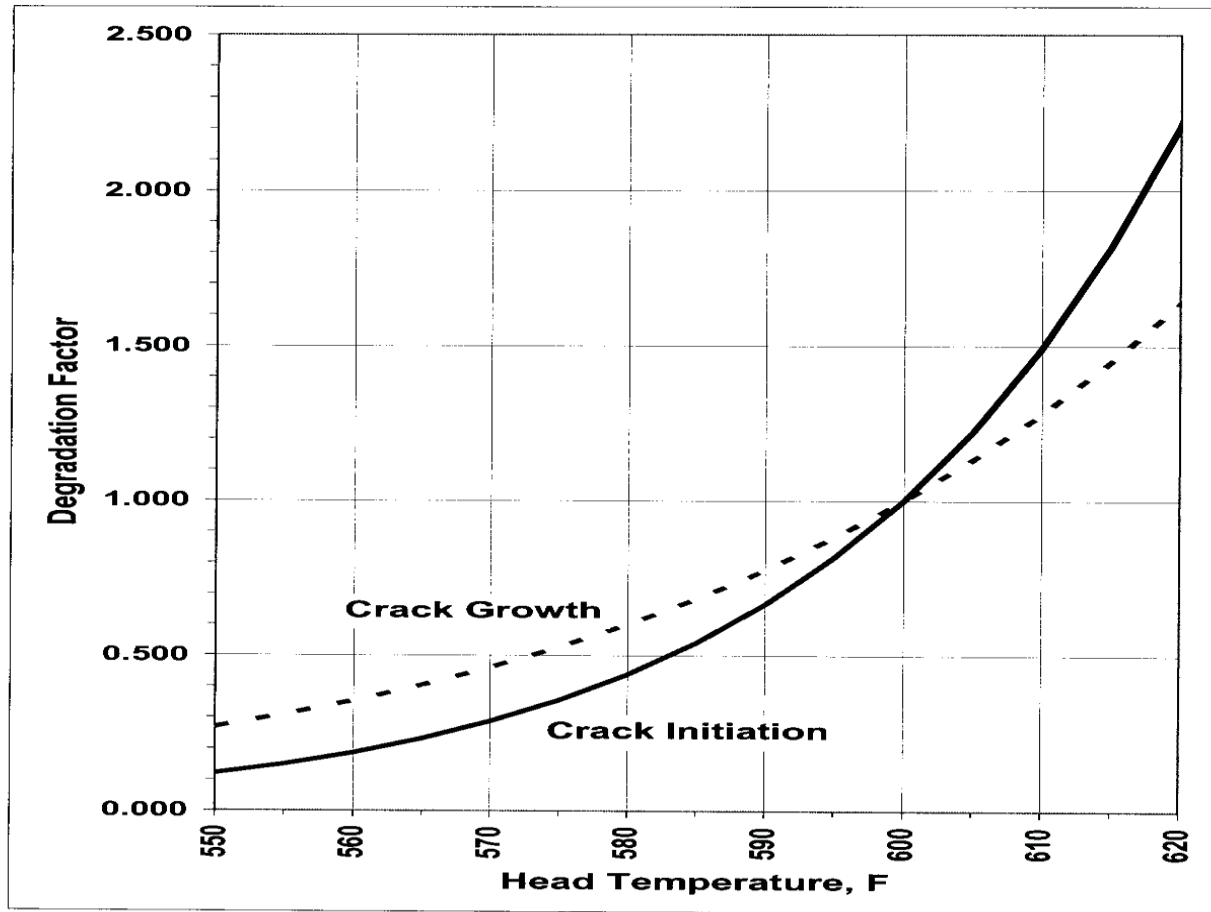
**Degradation Factor as a Function of
Temperature**
